## PRE - PURCHASE VISUAL BUILDING INSPECTION REPORT

**PROPERTY ADDRESS:**  
14 George Mobbs Drive, SAMPLE

**DATE OF INSPECTION:**  
30th Day of August 2016

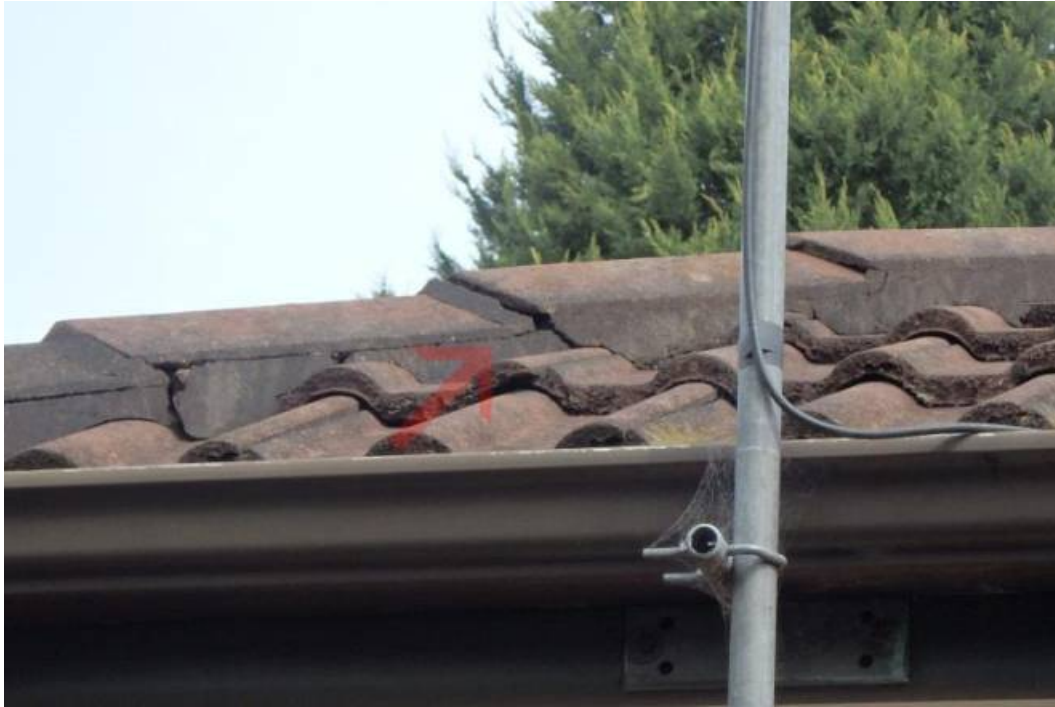
The overall condition of the roof coverings is fair. The mortar bed to the ridge capping is cracked and requires re bedding and pointing. It is recommended that the roof is resealed due to the age of the property, this will stop cracking and or prevent tiles from coming porous of roof tiles.

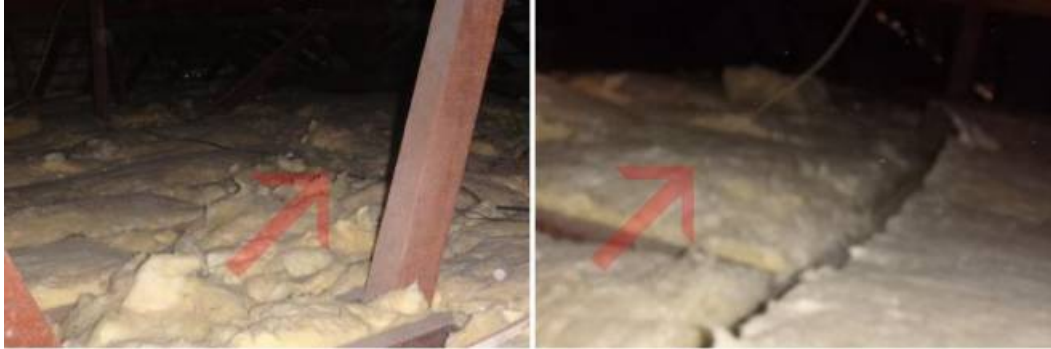
Insulation is present in the roof cavity. This restricted inspection to some roofing timbers. Removal of insulation is not within the scope of a standard visual inspection report. Insulation batts. No leaves were located to the roof at the time of the inspection.

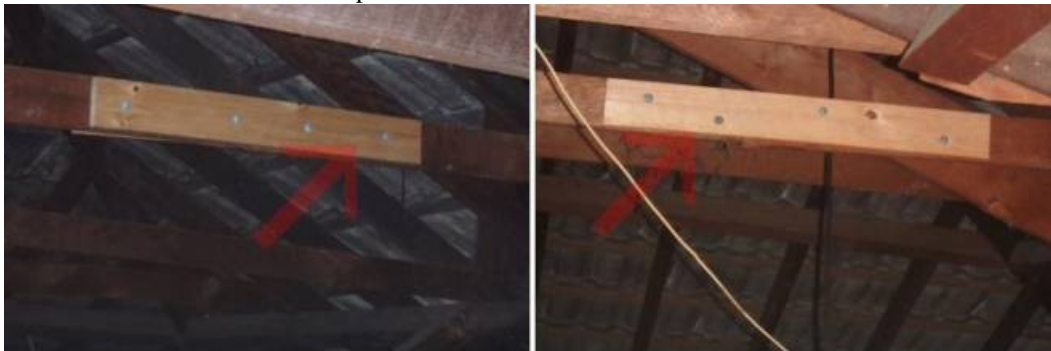
Collar ties have been repaired.

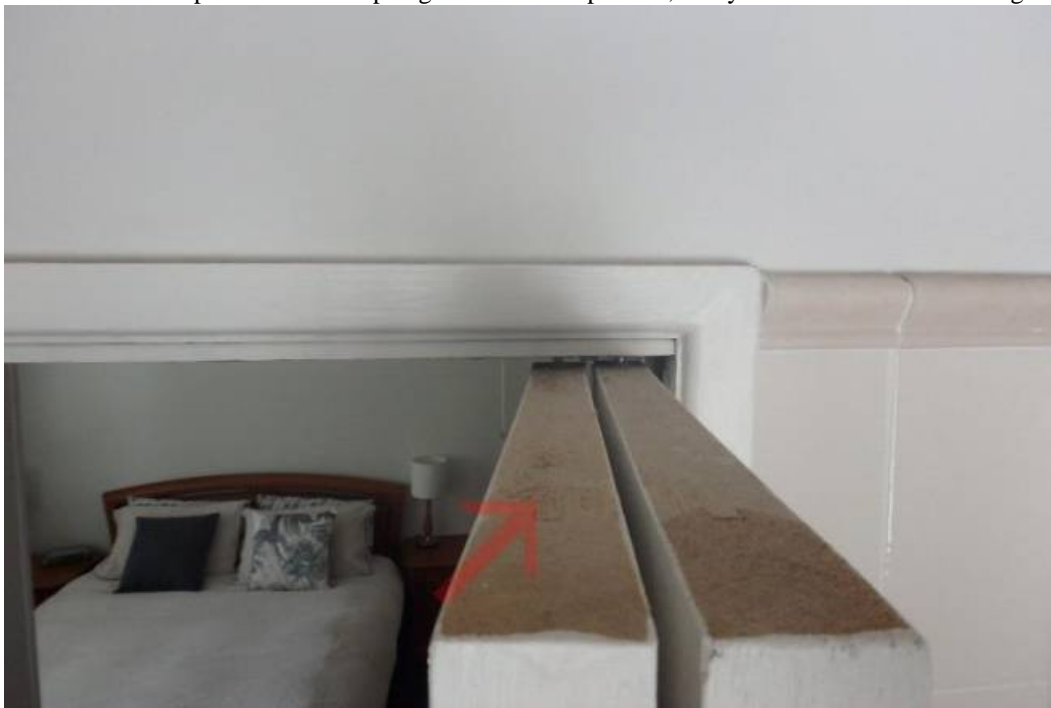
Laundry: Bathroom:

The condition of the doors is generally fair. The door binds and minor adjustments are required to ensure correct operation. The top edge of doors not painted, Entry door to subfloor is damaged and repairs required.

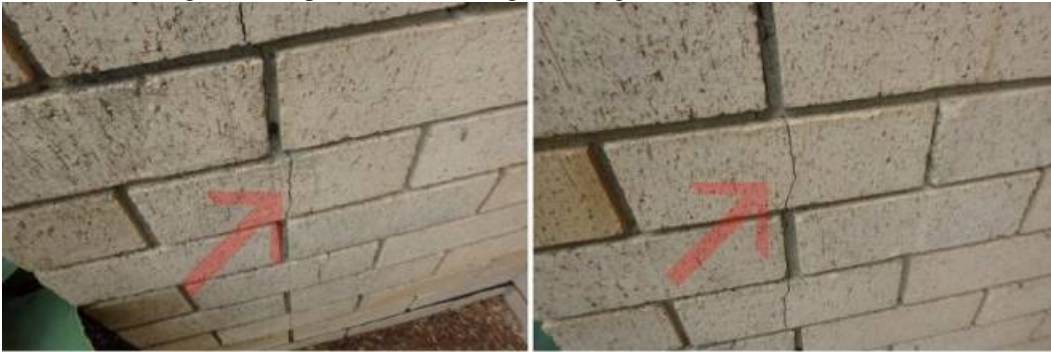
Front elevation.

Cracks are evident. Visible cracking has been categorized as a serviceability defect. Cracking of a building element is a serviceability defect where in the opinion of the inspector the function of the building element is impaired however, the expected consequence of this cracking is unknown until further information is obtained.

Cracking can be expected in a building of this age and construction.

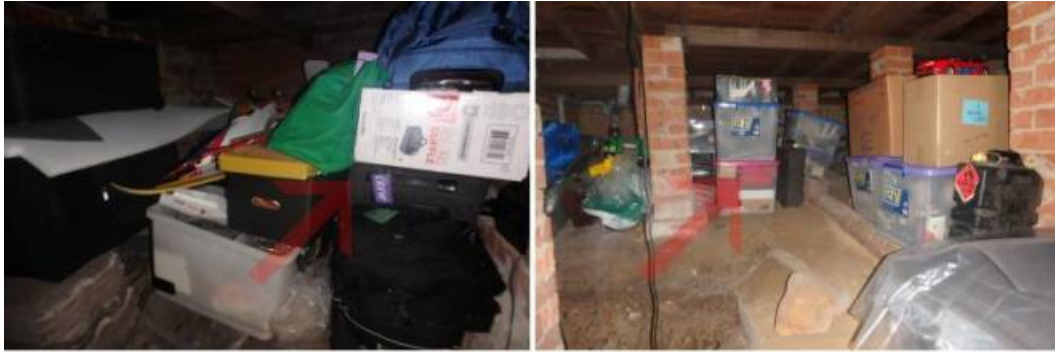
Below the following location or area:  
Various areas of the subfloor:

There appears to be moderate damage consistent with timber pest attack to visible accessible timbers.

Wall Frame timbers:

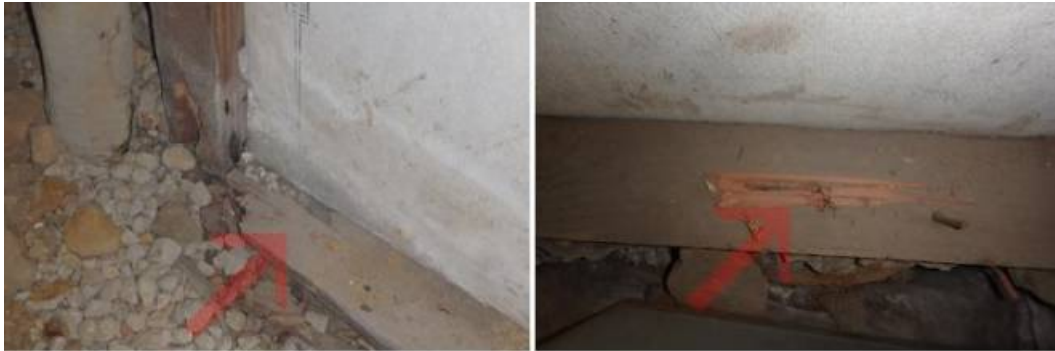
Below the following location or area:  
Right hand section:

Minor wood decay damage was noted. Maintenance and repair is required.

Bearers:

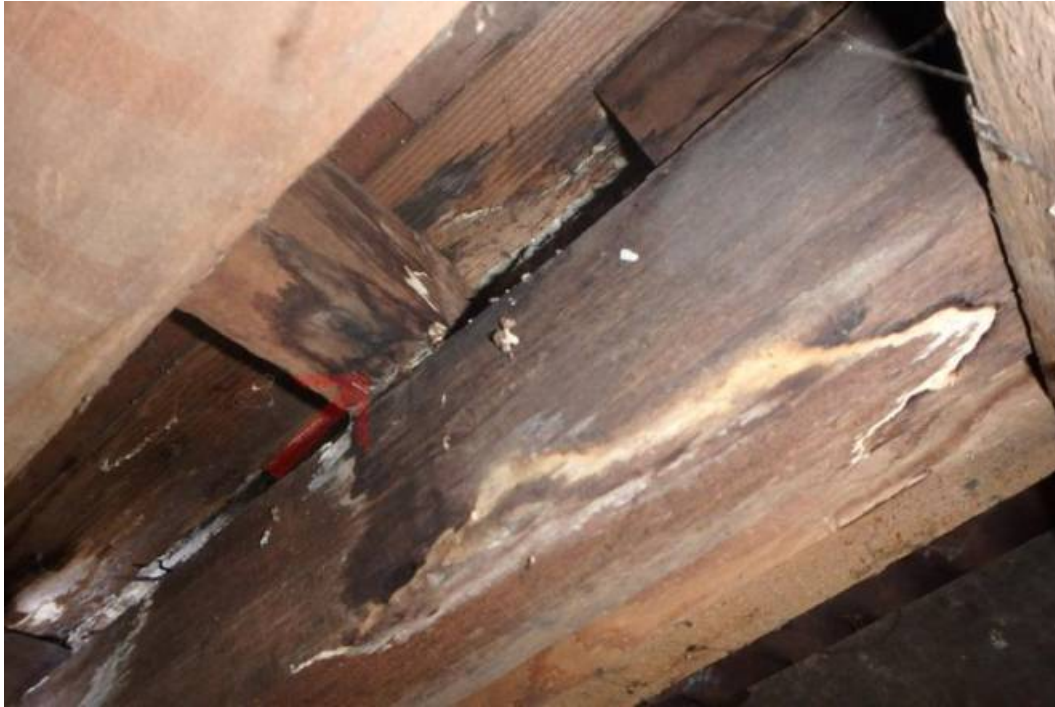
Below the following location or area:  
Main bathroom:

The underfloor ventilation appeared to be limited. This may provide conditions that could encourage decay of timber components. Upgrading of the ventilation is recommended. If necessary, contact a Licensed Builder for advise and rectification.

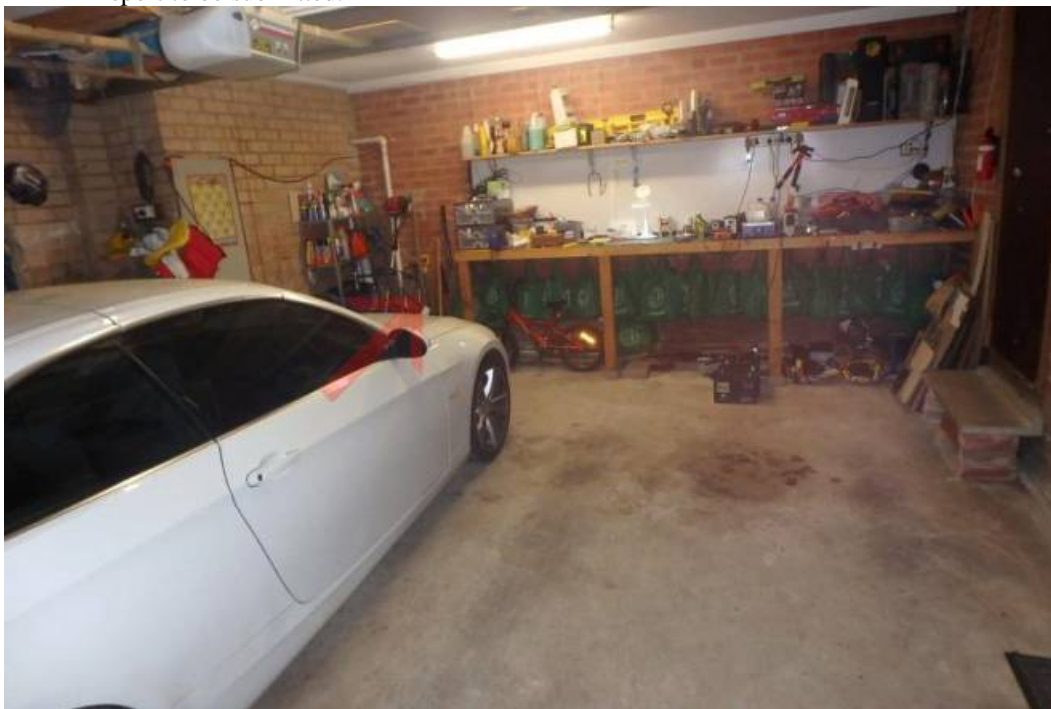
Stored items restricted inspection to the interior. Stored items should be removed to enable a more complete report to be submitted.

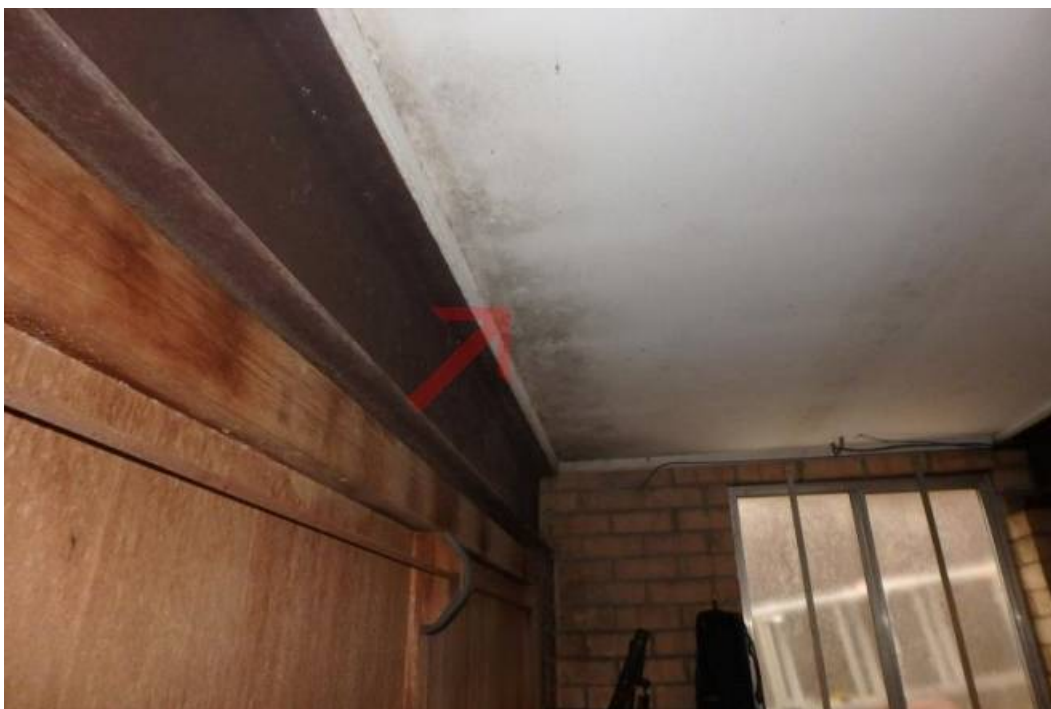
Nails are popping and are visible. This is generally due to movement in the timber framing. Periodic maintenance may be required and ceilings may need to be re-secured. Evidence of past water penetration through the ceiling. No evidence of any current leaks. Mould was noted to the ceilings. The cause of this should be investigated and rectified.

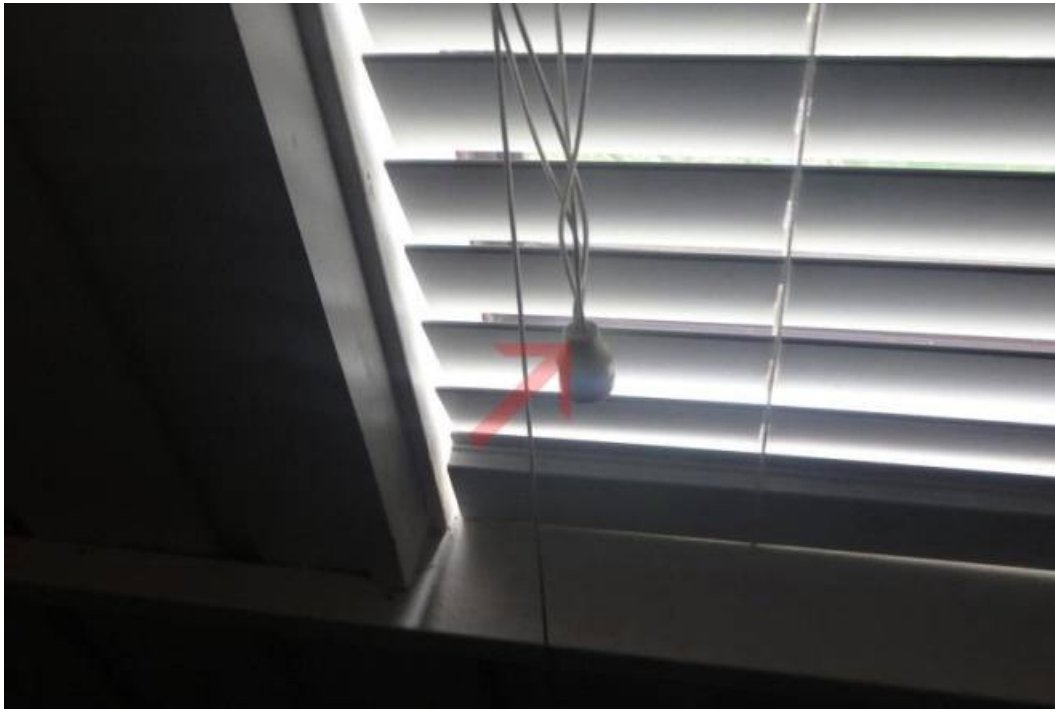
Trees: All or any trees associated to this property are to be assessed by an Arborist for their strength and in the event of any issues then these issues are to be dealt with immediately. Windows to a two storey home of higher should have locks fitted so that opening is no greater than 125mm, Window blinds and or cords should be secured as this is a safety issue, Low head height at stairwell.

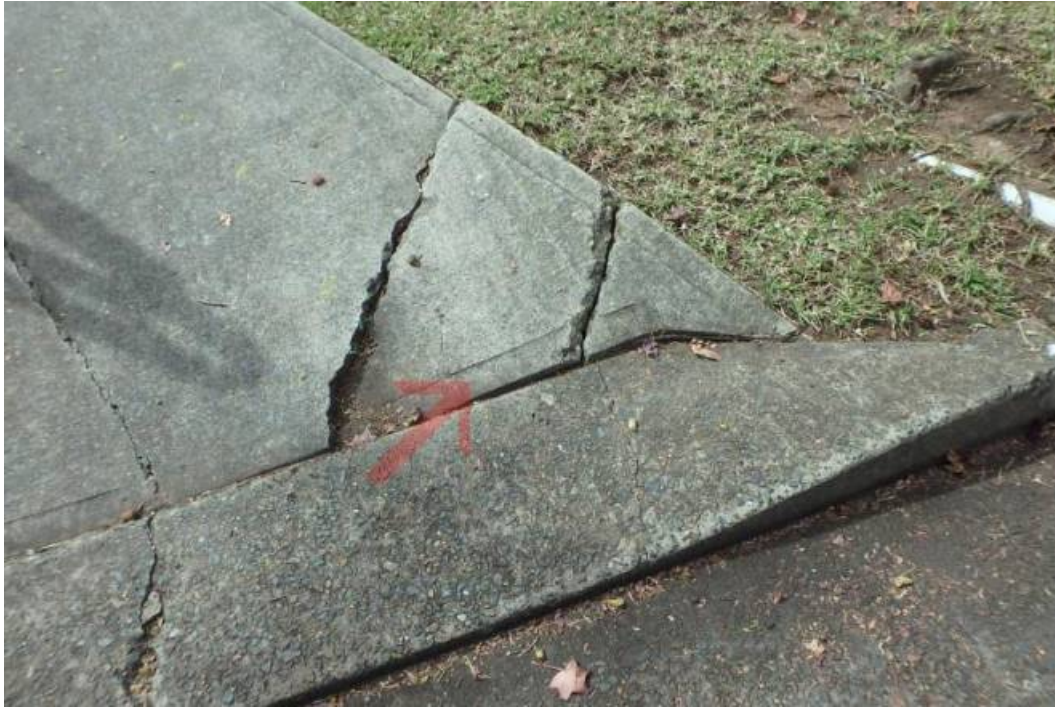
The concrete driveway has some visible cracking that should be monitored for further movement. The concrete driveway has subsided in some areas and will require repair. This may present a tripping hazard and rectification is required. The driveway should be monitored during heavy rain to determine whether the existing drains can cope.
